Manhole Inspection Summary

Manhole # S17EE2015MH

Insp Date: **10/25/06 8:58 PM**

Location Address: **1901 KELLY AVE**

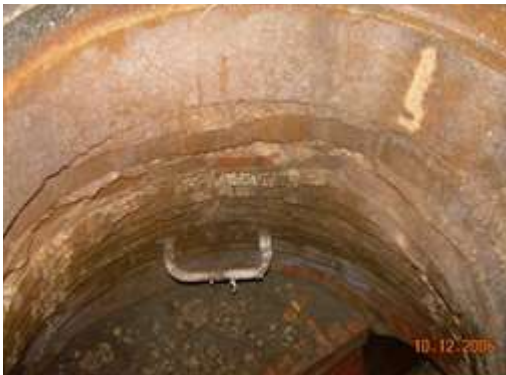
Defect

Frame Offset: **0** (in.) Condition: ☐ Sound ☐ Cracked ☒ **Leaks**

Condition: ☐ Sound ☐ Cracked ☐ Root Intrusion ☐ Loose Brick ☒ **Deteriorated**

Infiltration: ☐ None ☐ Joint ☐ Cracks ☒ **Mortar** ☐ Roots ☒ **Wall**

Frame leaks. Corbel deterioration and infiltration.

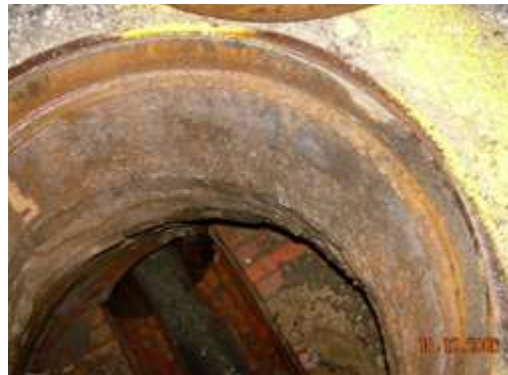
Defect

Frame leaks.

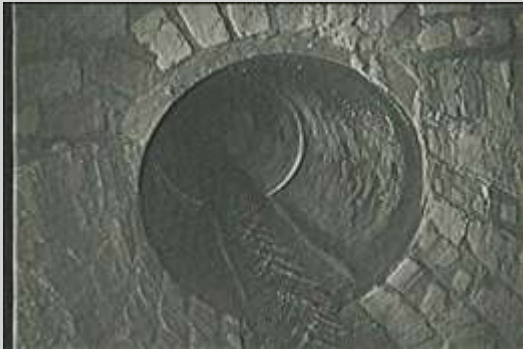
18 in. Circular Gravity Sewer Pipe Out @ 12 O'Clock

Infiltration: **Evidence** Pipe Seal Cond: **Unknown**
